PHENIX WEEKLY PLANNING

TECHNICAL
SUPPORT
NO. 1

6/16/2011
Don Lynch

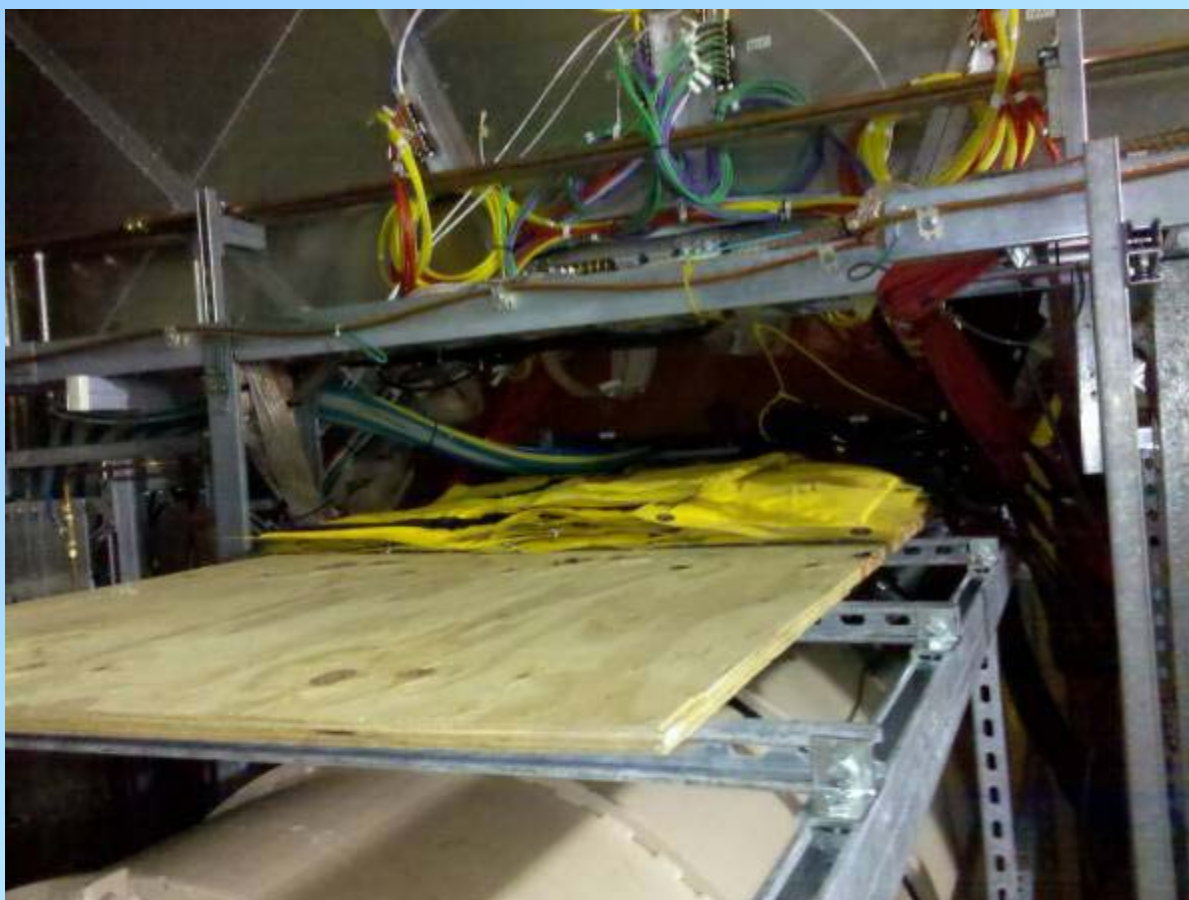
North Station-1 and -2 Re-capacitation & Termination

Reduces cross-talk/big pulses by factor of ~ 3

- documentation & disassembly
- install north station-1 capacitors (gaps 2,3) & terminators
- install terminators on upstream parts of north station-2 (concurrent with above)
- reinstall station-1 chambers and FEE
- re-cable, get working, & extensive testing (with HV/gas)

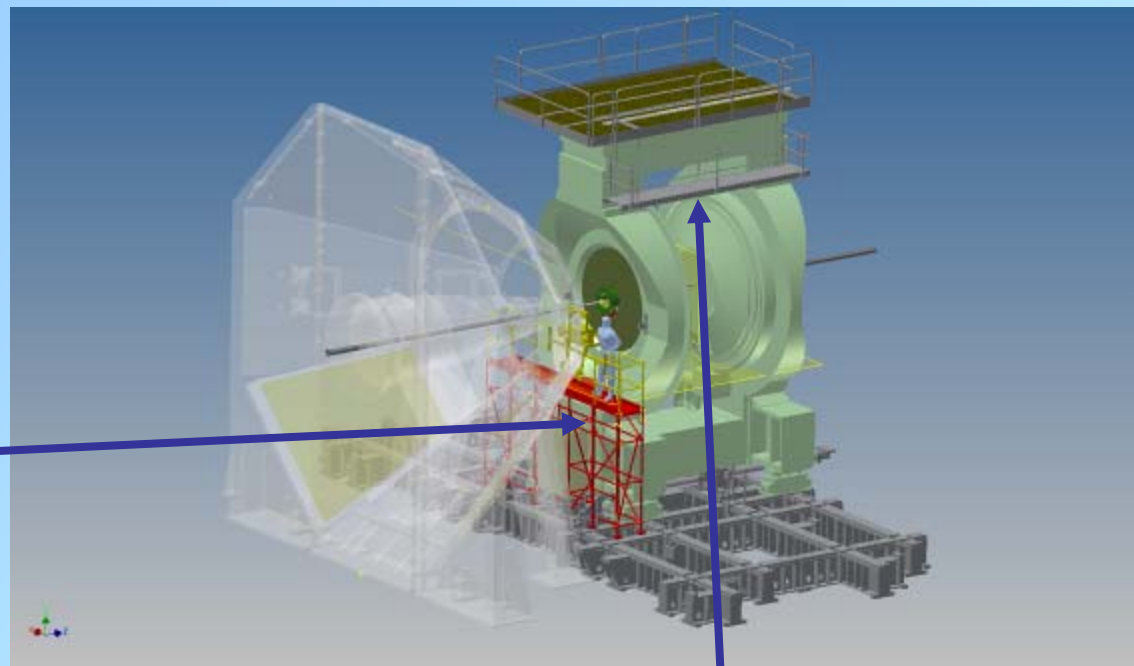
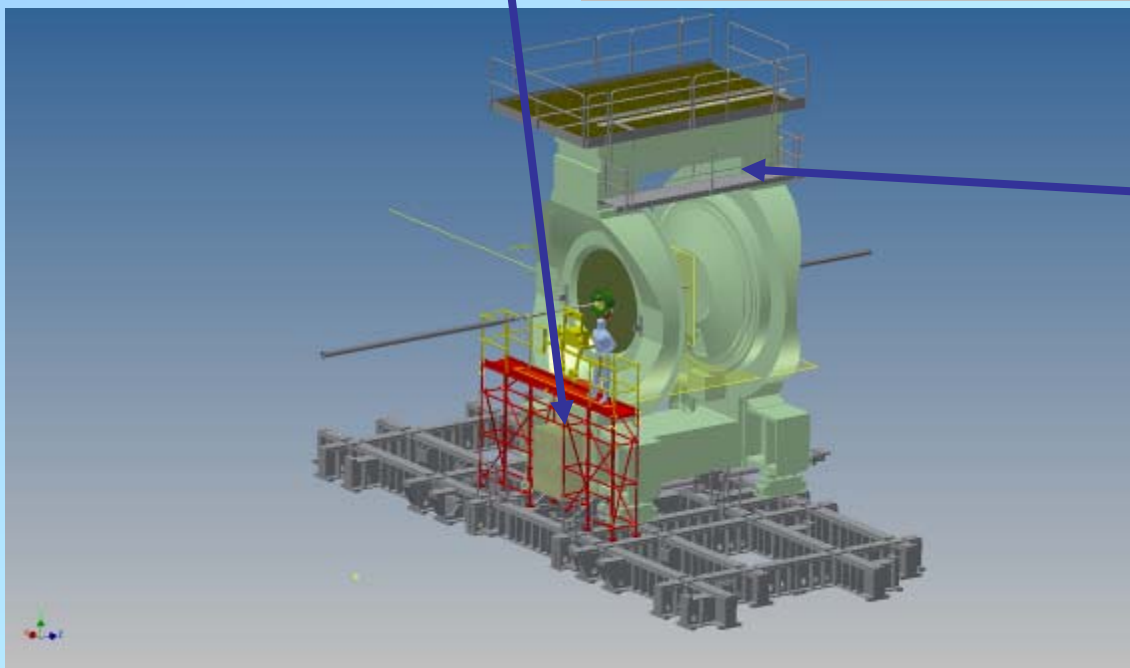
Station 1 platform configured for lower level access shown with North Muon Magnet in phantom for reference and invisible for clarity.

Central Magnet suspended work platform also shown in both models.

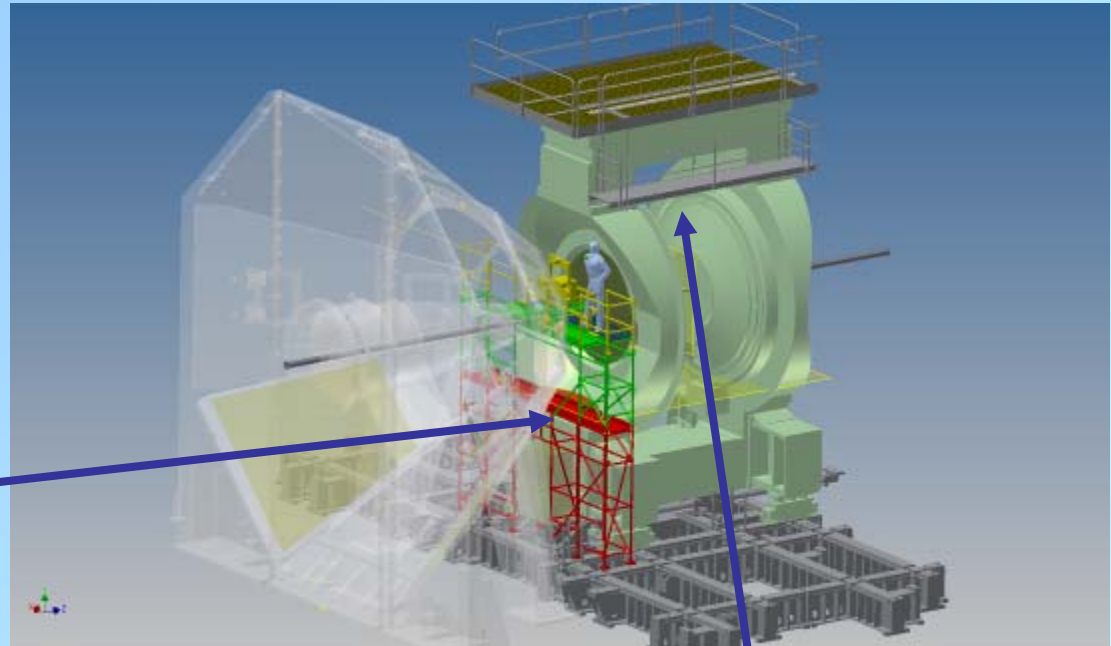
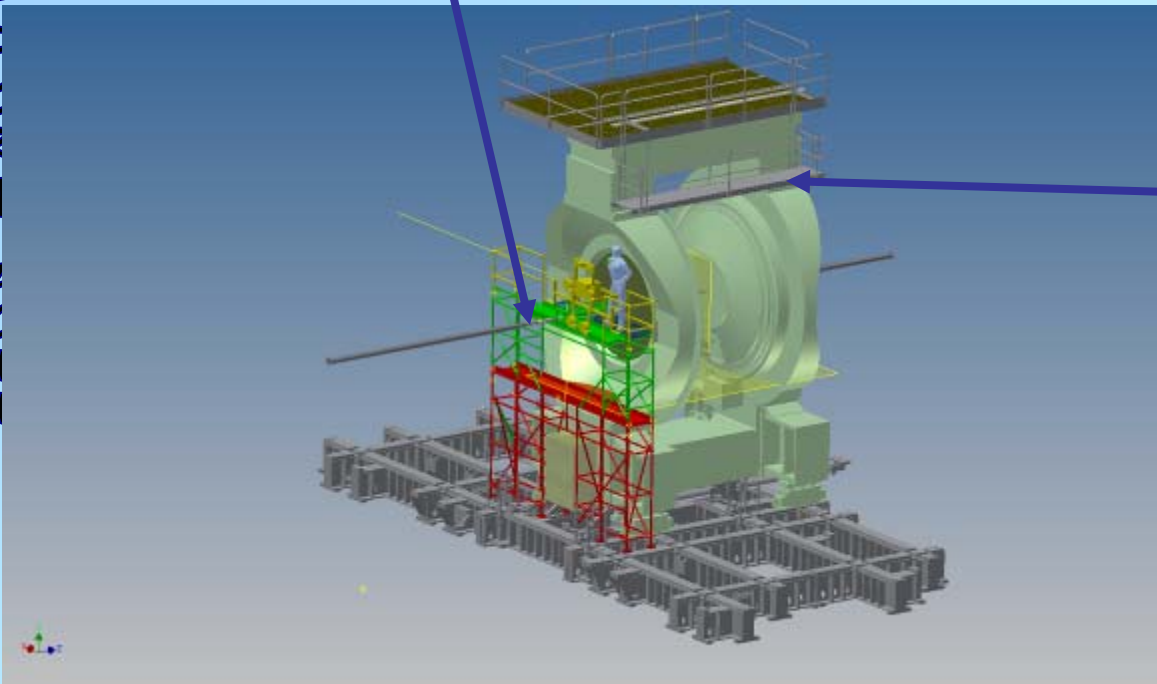
Station 1 platform configured for upper level access shown with North Muon Magnet in phantom for reference and invisible for clarity.

Central Magnet suspended work platform also shown in both models.

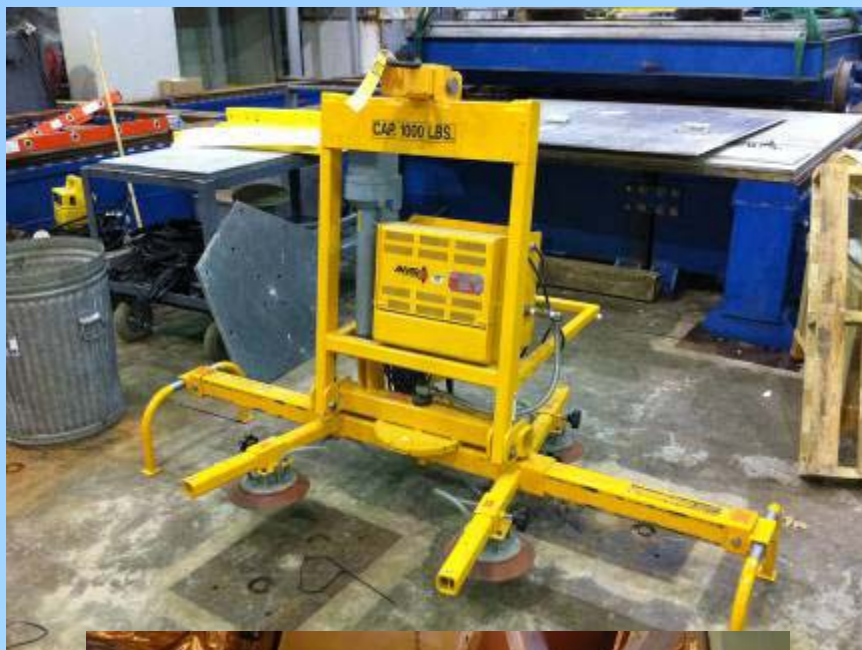
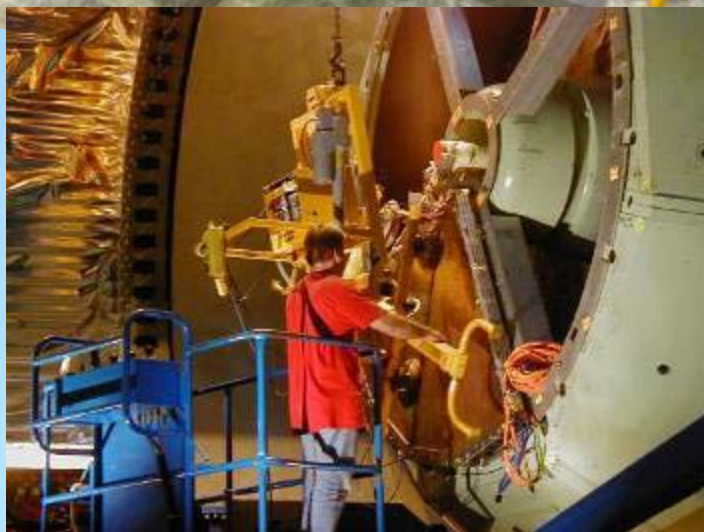
Station 2 access (MMS shown
MMN is similar)

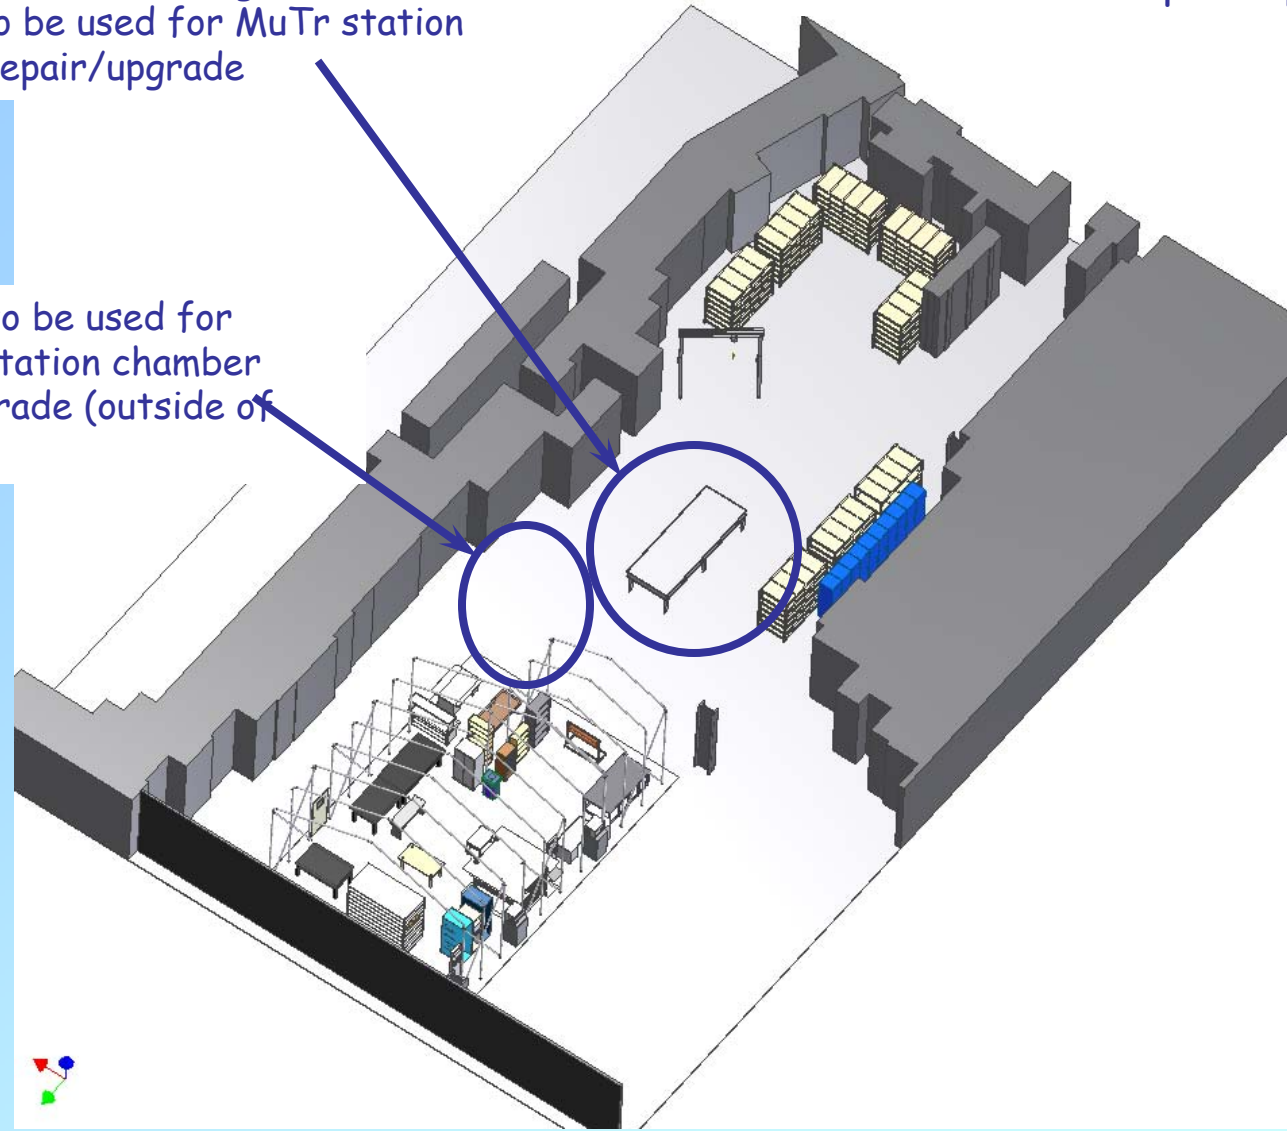
This area (previously occupied by burn-in test stand and enclosing tent, now just tent) to be used for MuTr station 1 chamber repair/upgrade

This area to be used for soldering station chamber repair/upgrade (outside of tents)

RPC Factory site to be utilized by both RPC1 fabrication/testing and MuTr station 1 chamber repair/upgrade

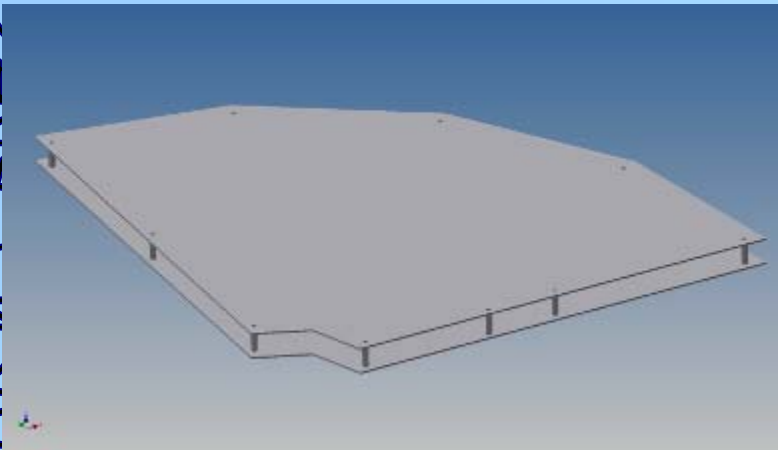
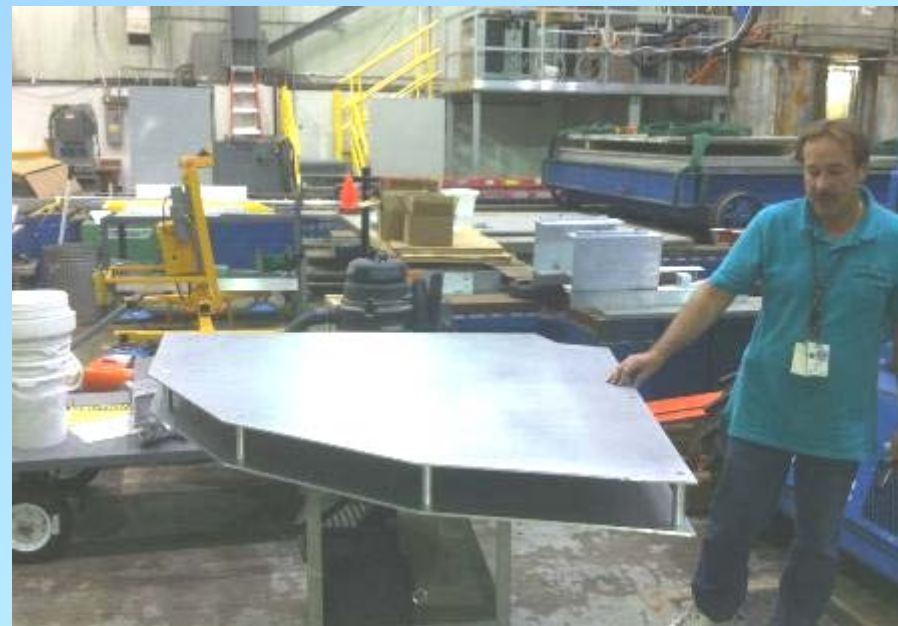
Dummy MuTr Station 1 Octant. Will be used to re-qualify vacuum lifting fixture and to practice using vacuum lifting fixture prior to removing station 1 north octants.

Dummy MuTr load received from CS, assembly in progress

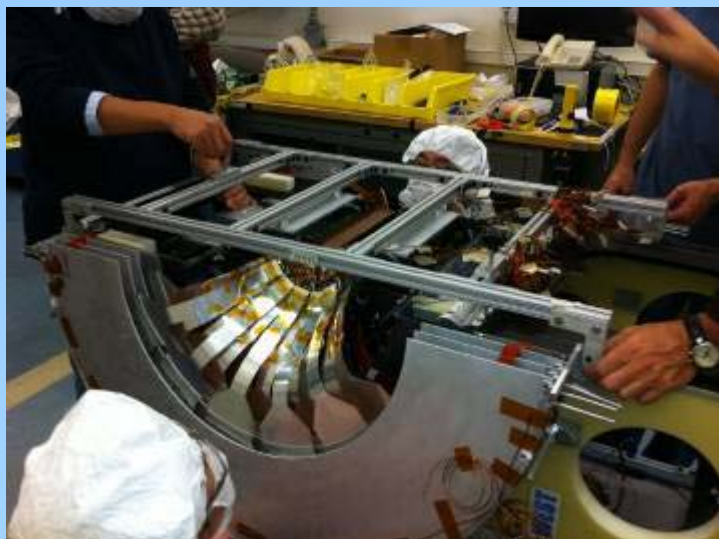
VTX Assemblies
2 half detectors,
4 barrels per
detector

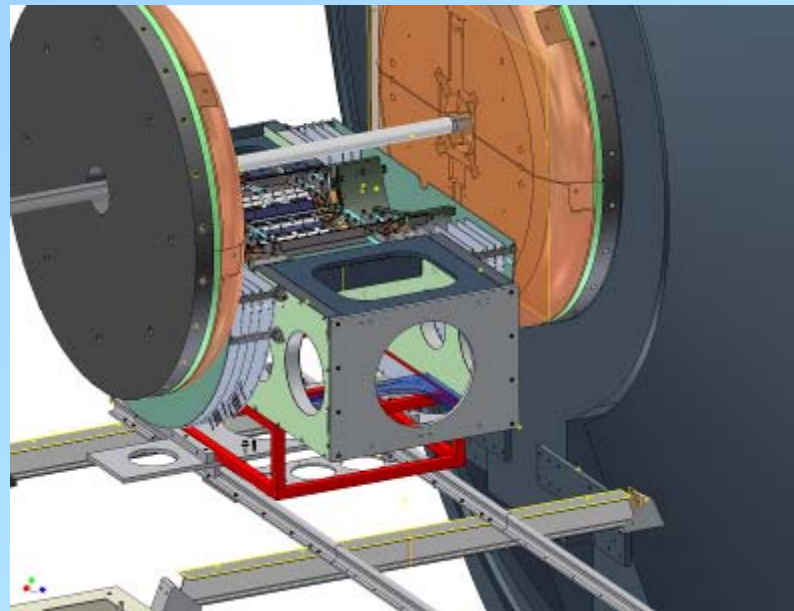
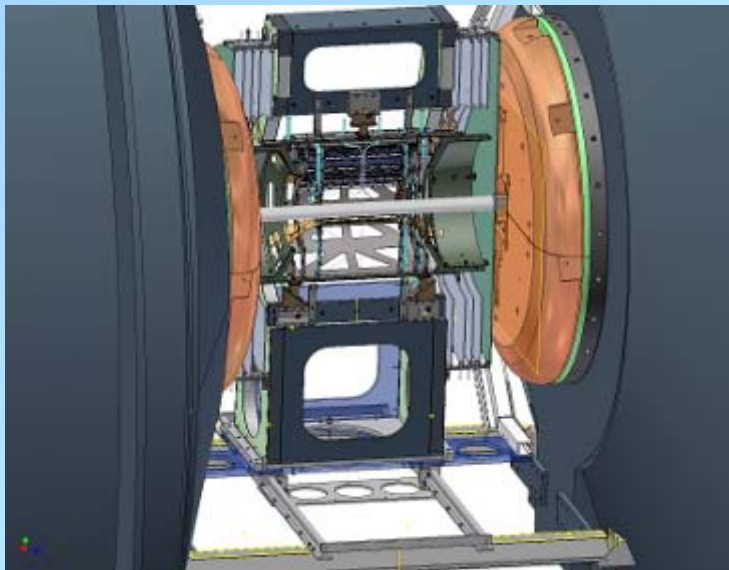
West $\frac{1}{2}$ of VTX lifted by crane with slings to extended rail and slid under BP to the west rail extension, then rotated with slings and crane to upright position and placed on west side in approximate final position. East side then lifted with slings and place on east extended rails. Final alignment and alignment stops added with survey group.

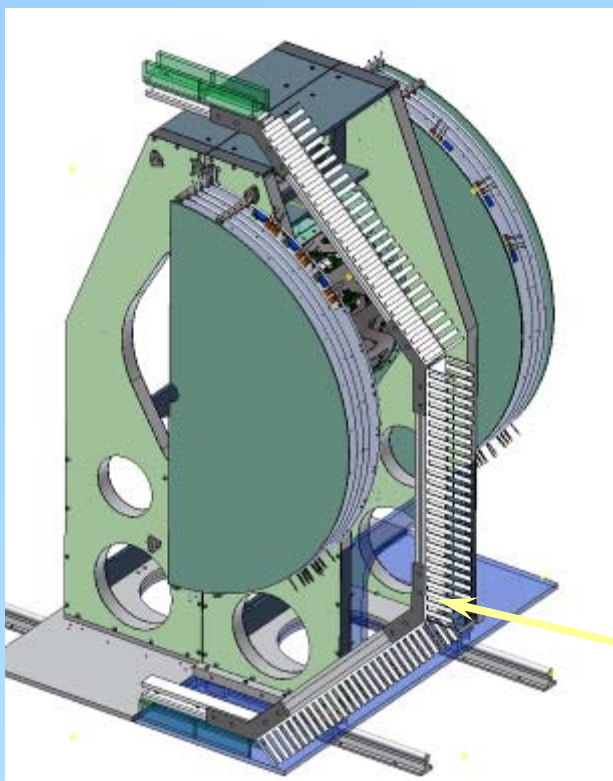
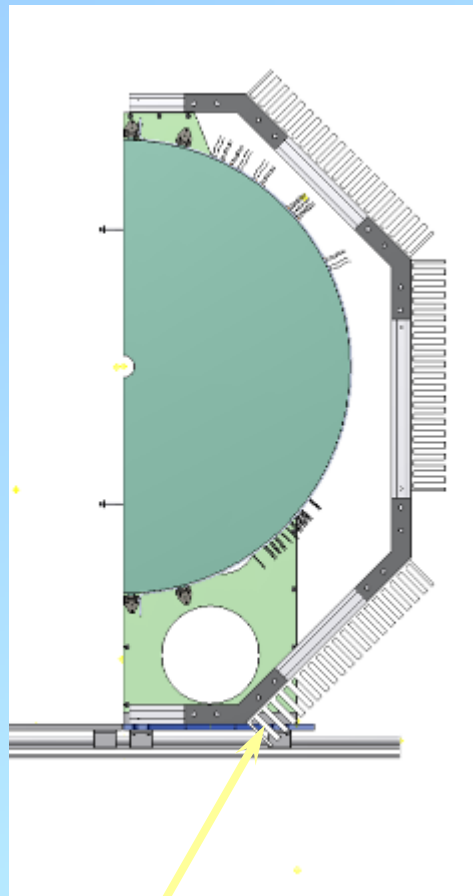
VTX cable tray concept

2010
(3" wide)

2011
(6" wide)

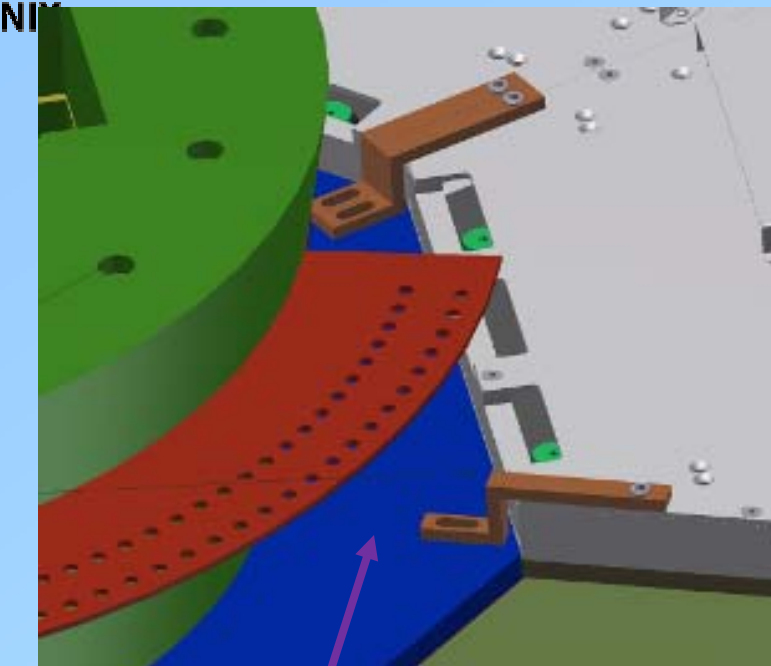
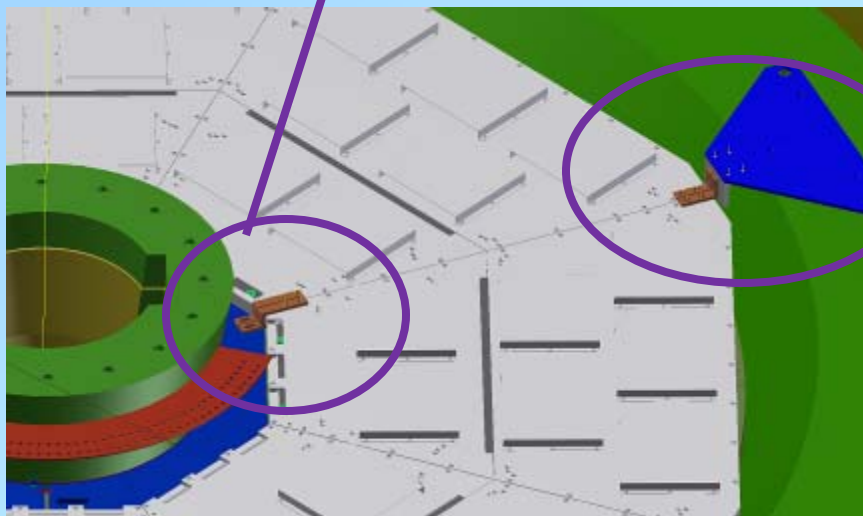
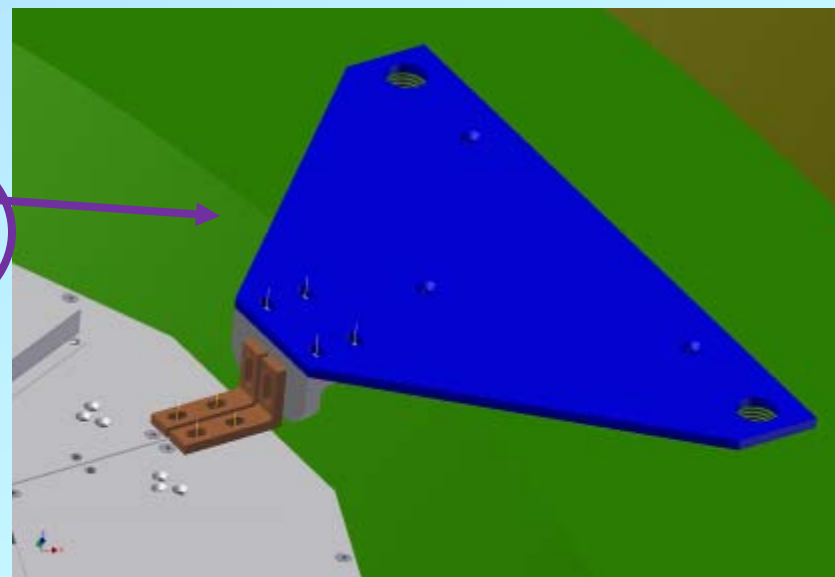
RPC1 Mounting Concept

Octants are individually mounted then tied together and supported at the outer octant boundaries by brackets mounted on existing tapped holes, and on inner edges by rings which wedge against the flower pot lead liner. Tapped holes in 8 places on each octant are used both to mount the absorber section and to attach the mounting brackets.

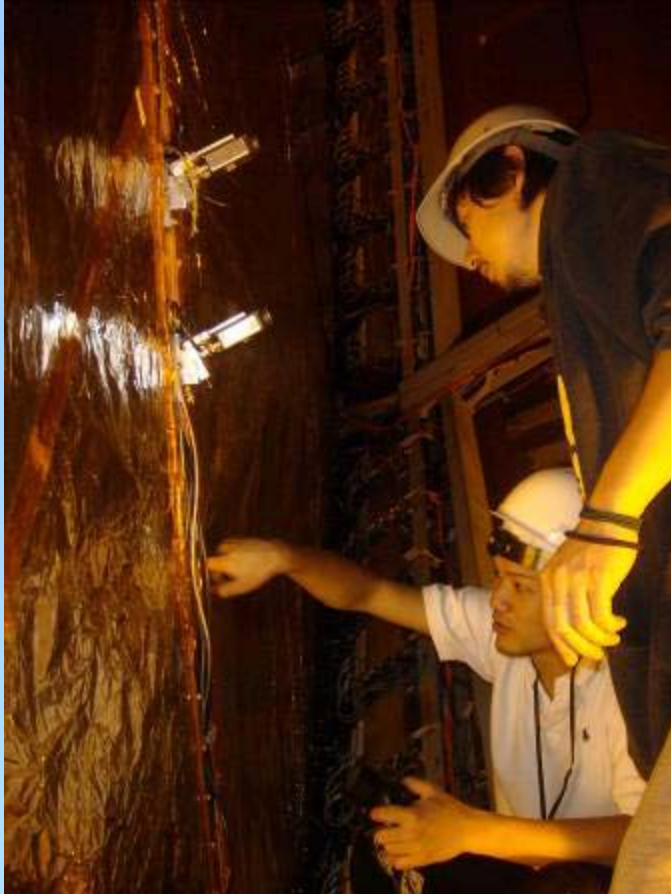
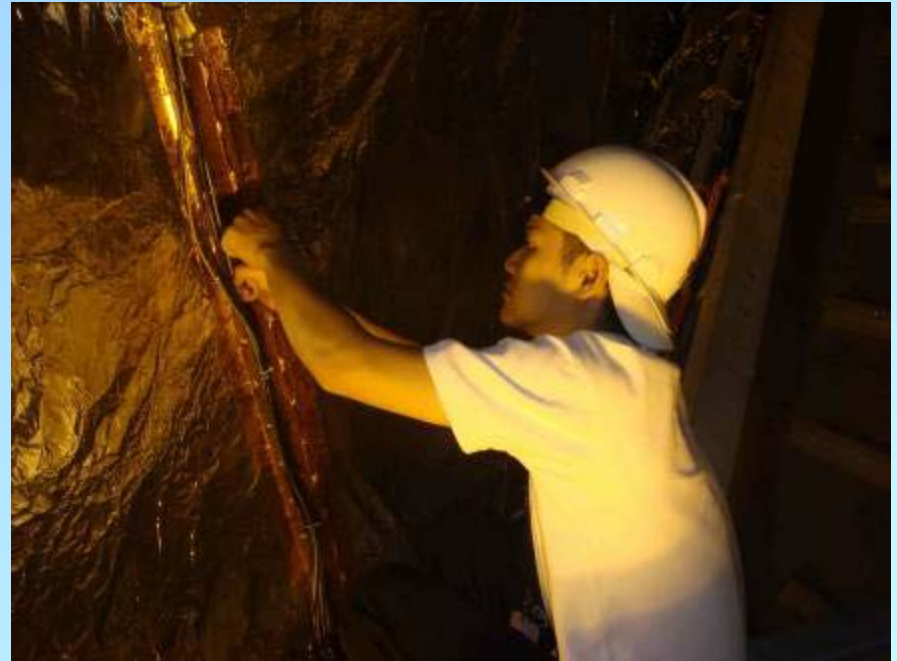
Station-3 Clamp Installation

- Anode card Inspection with mirror : < 5min./clamp.
- Anode clean up if necessary : < 15 min./clamp
- Clamp mount : ~ 5min./clamp
- Voltage readout : 5min./clamp
- HV test : 10min.
- Total : 25 ~ 40 min./clamp

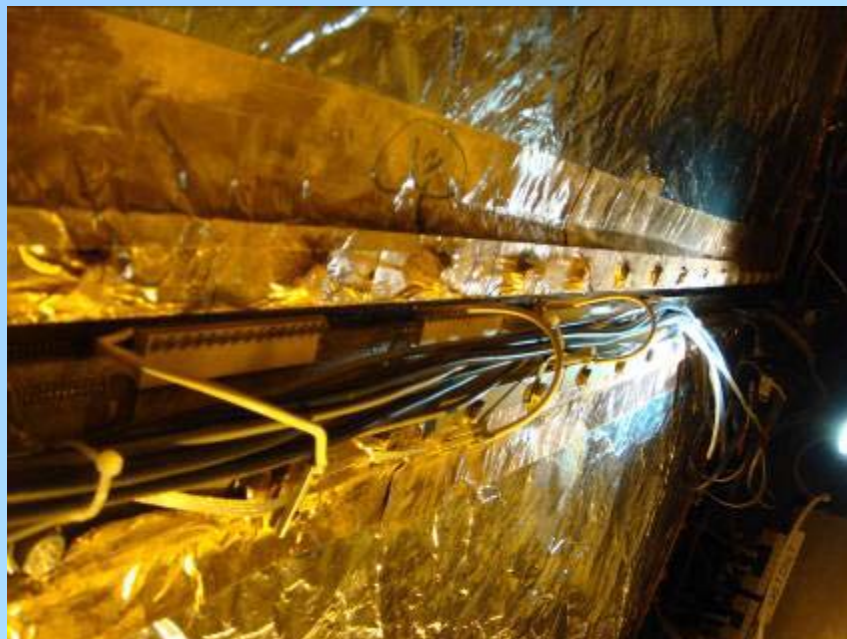
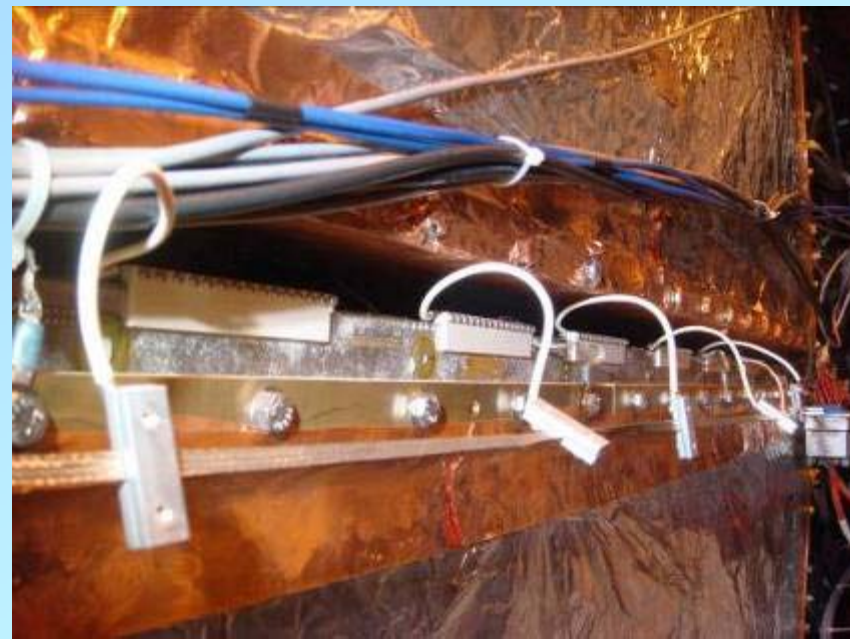
MuTr Station 2/3 Recapacitation clamps

Installed Clamps

Octant 7

Octant 8

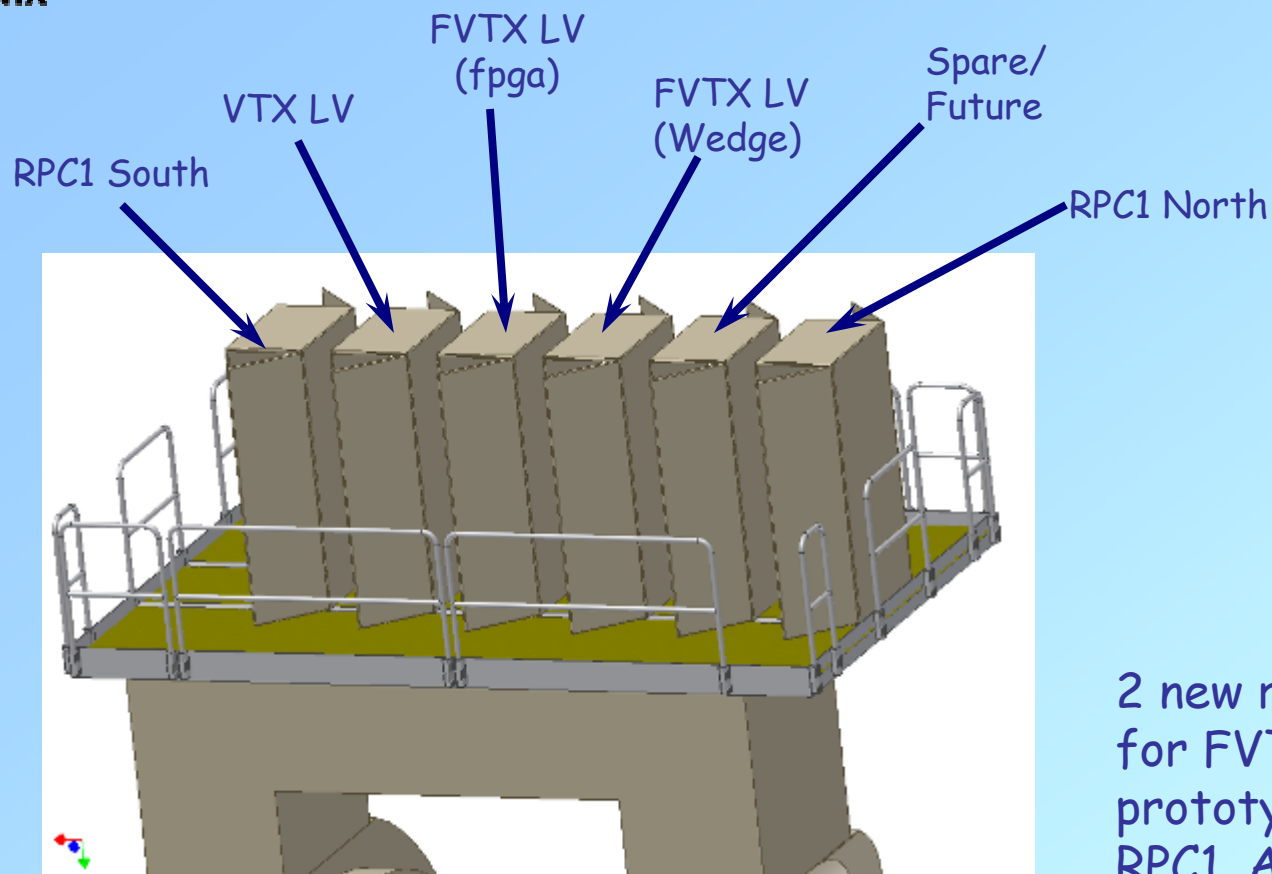
2 new racks to be added for FVTX, 1 new and prototype upgraded for RPC1. All racks will be equipped with standard PHENIX heat, smoke and water leak detection.

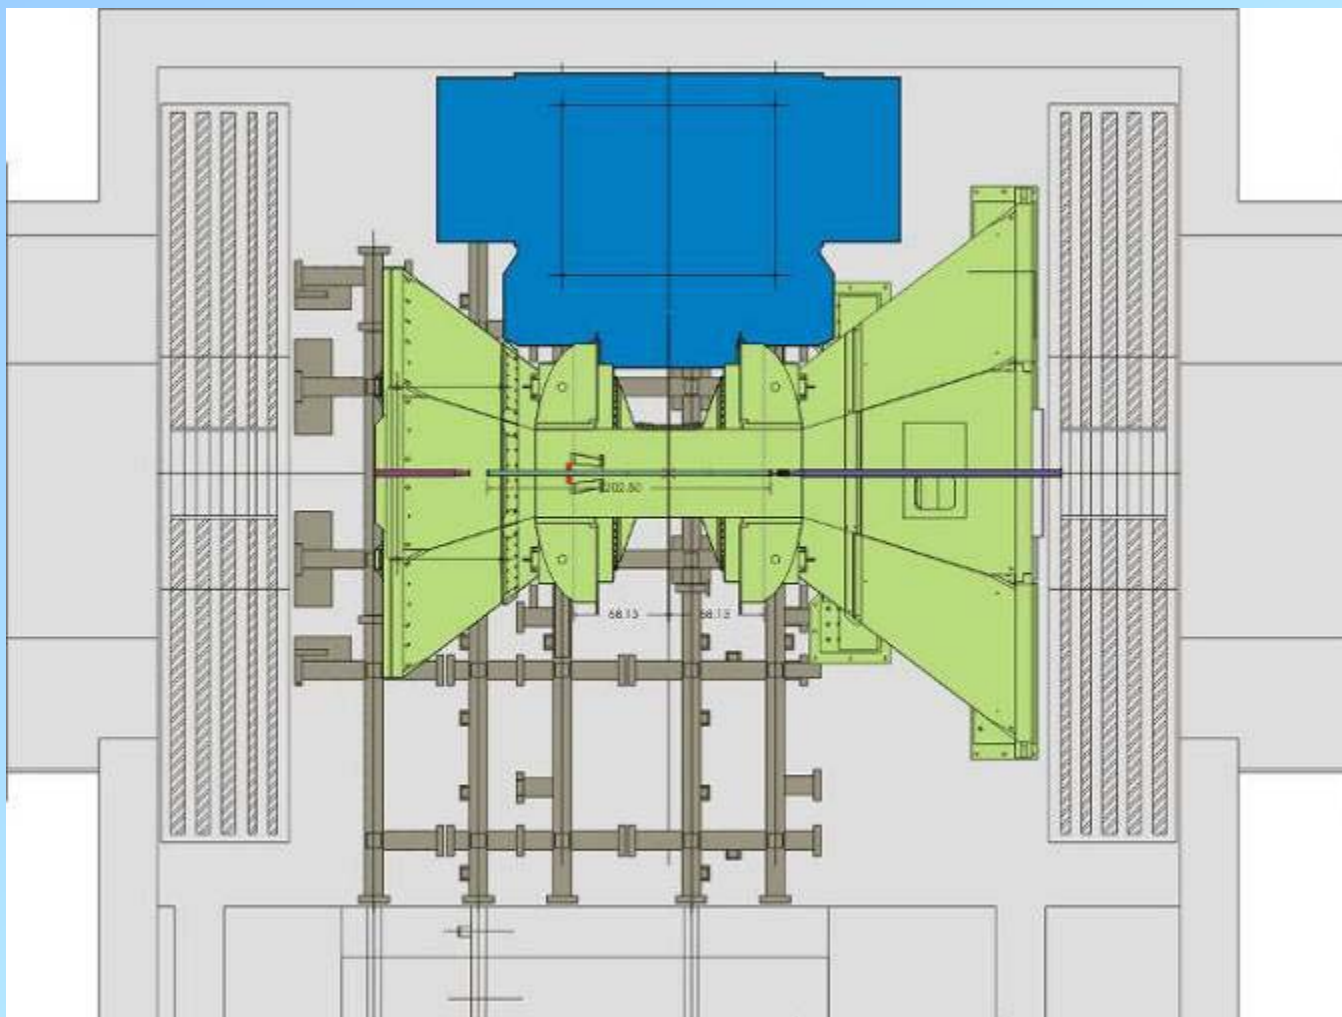
IR is currently in this (Run) configuration. (MuID collars not shown)

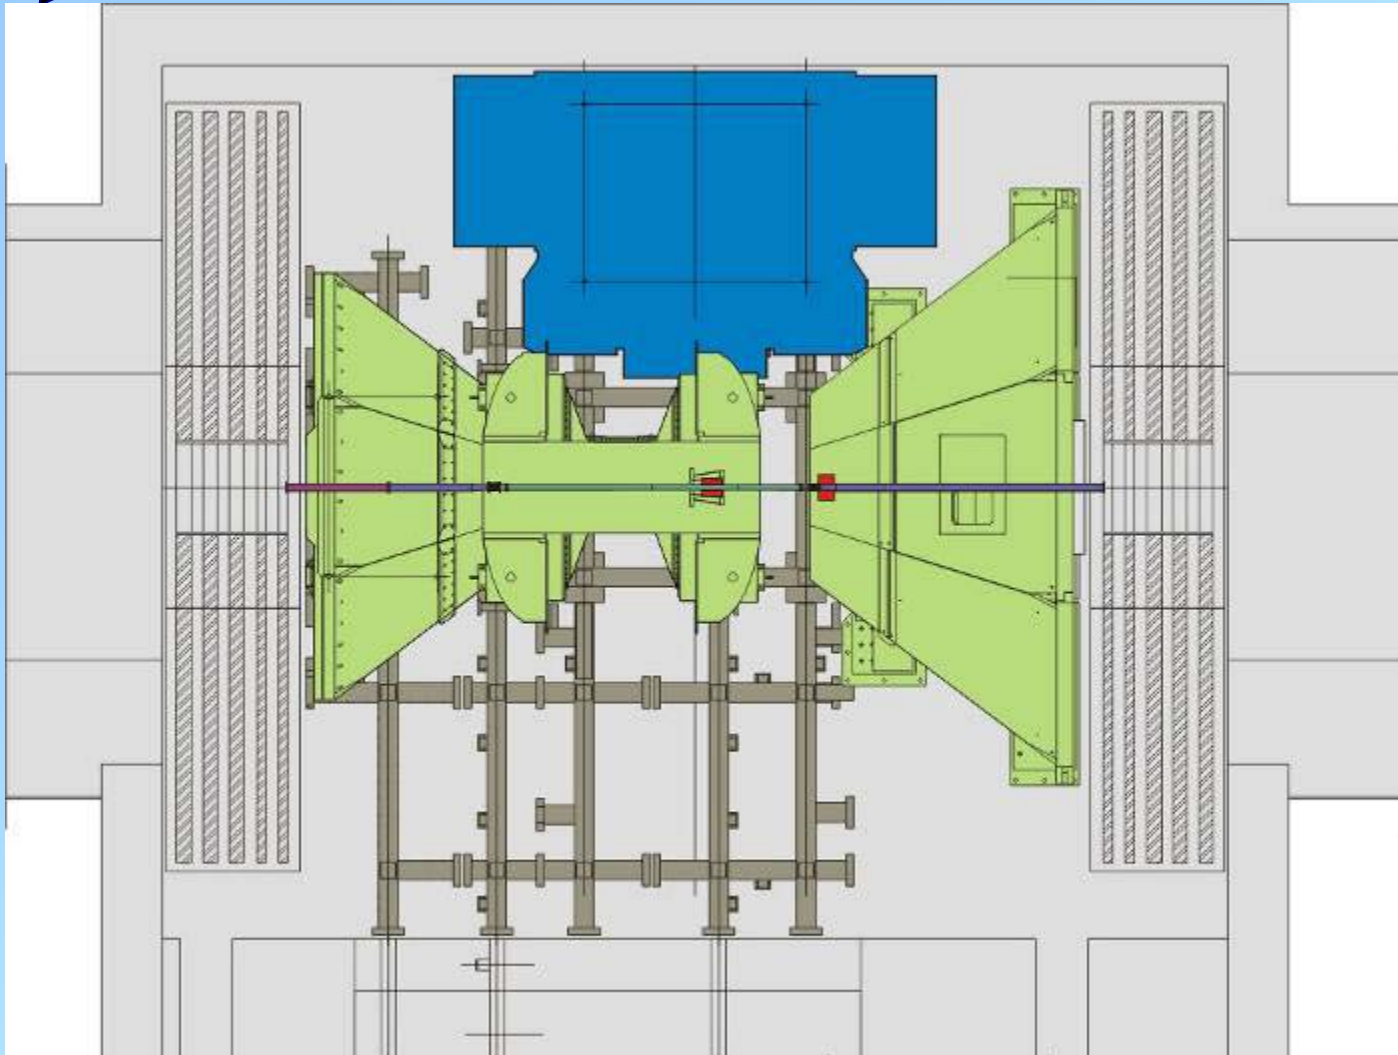
After MuID collars are removed and EC is moved to AH, MMS is moved south. CM is then moved south to gain access to Station 1 North. IR remains in this configuration until MuTr station 1 north work is completed and RPC1 north has been installed.

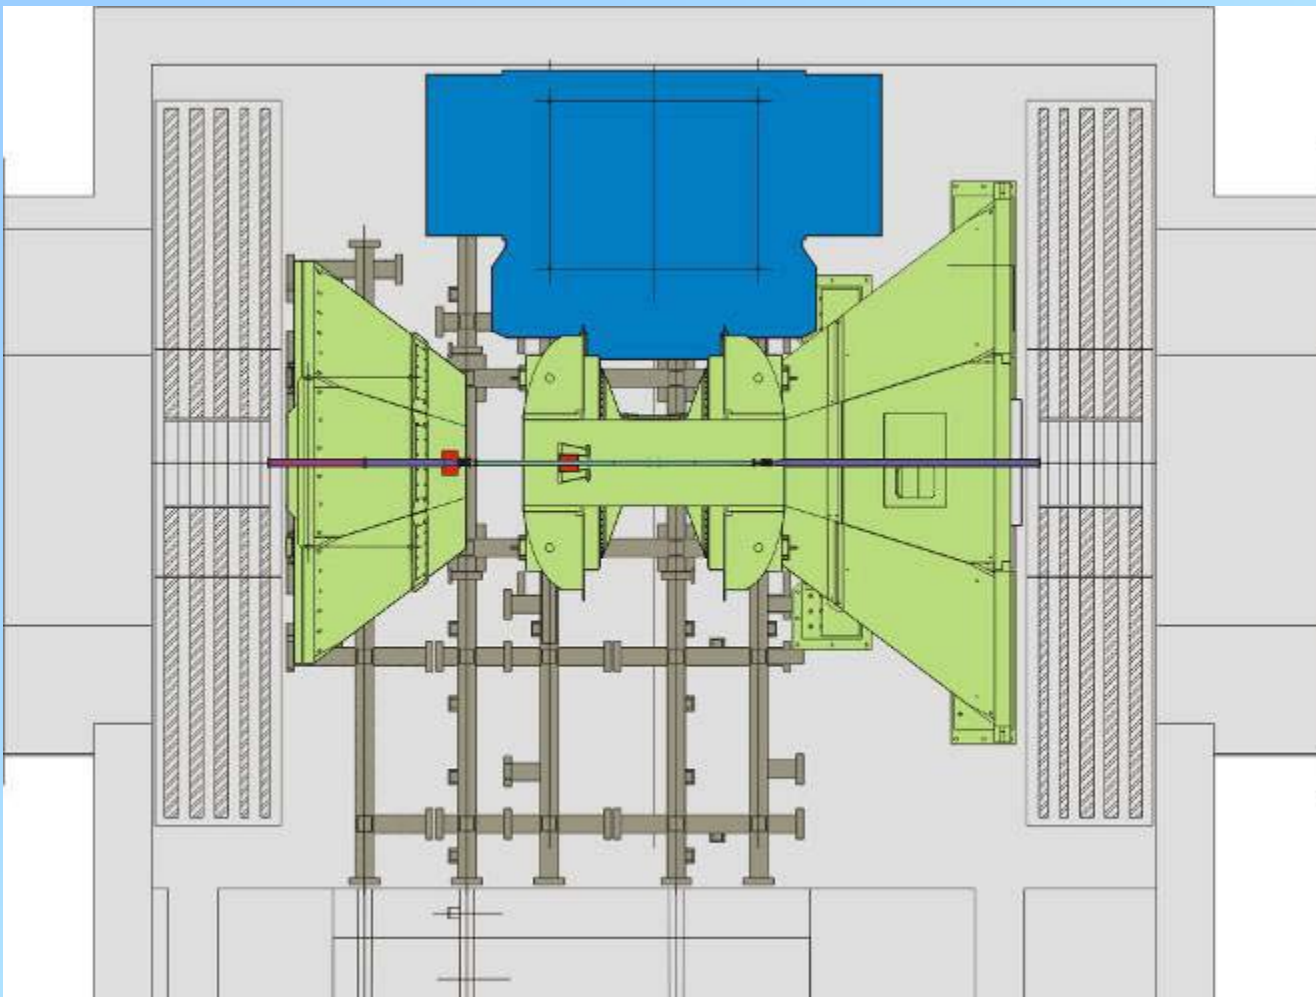
CM is then moved north to gain access to station 1 south. After RPC1 south has been installed and EC has been returned to IR MMS will be moved north and the IR is restored to Run configuration.
